THE GROUND MOVEMENTS RELATED
TO BRACED EXCAVATION AND
THEIR INFLUENCE ON ADJACENT
BUILDINGS

Illinois Univ at Urbana-Champaign Dept of Civil Engineering

August 1976

Report No. DOT-TST 76T-23

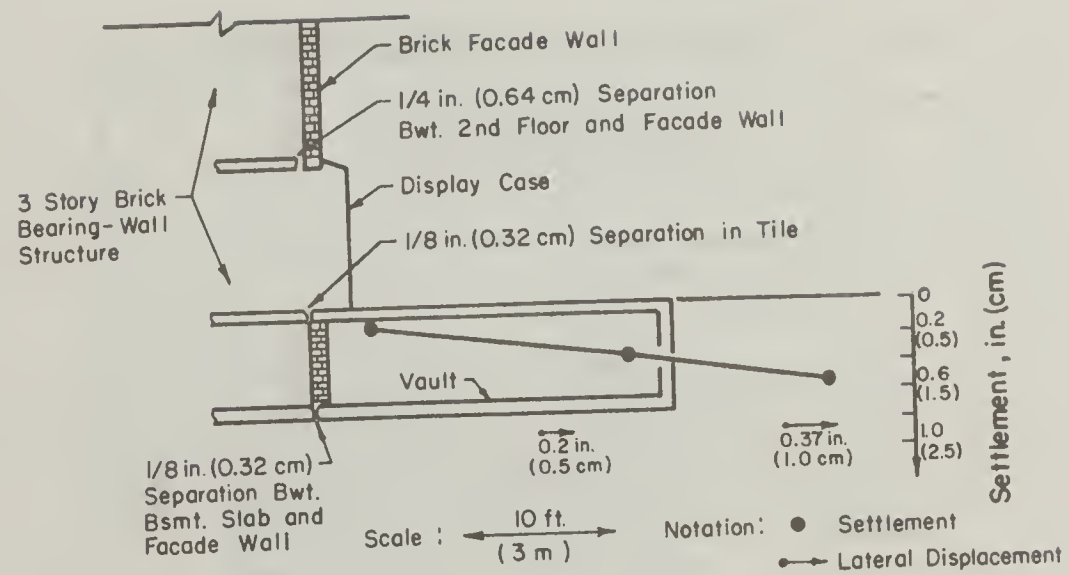
a) Detail of 3-story Building

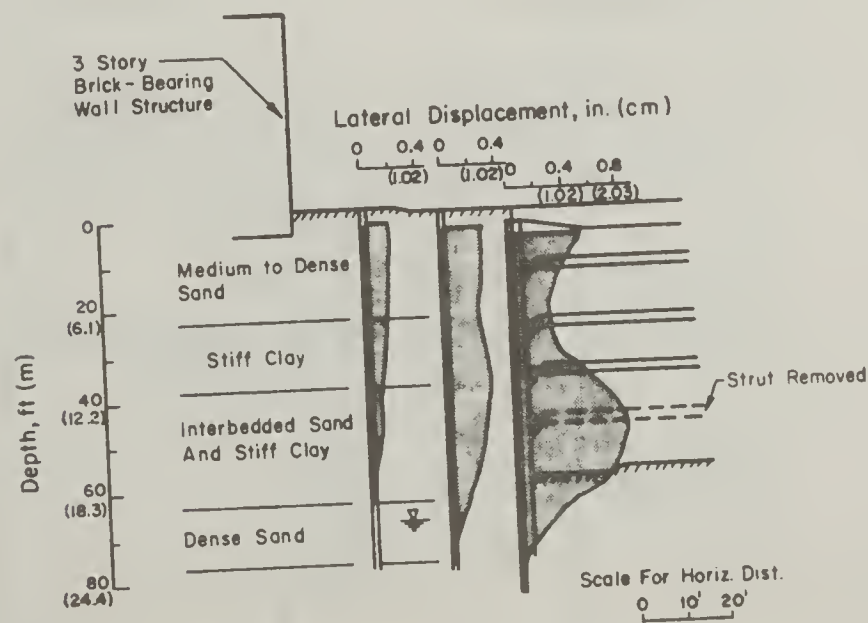
b) Lateral Displacement Profiles

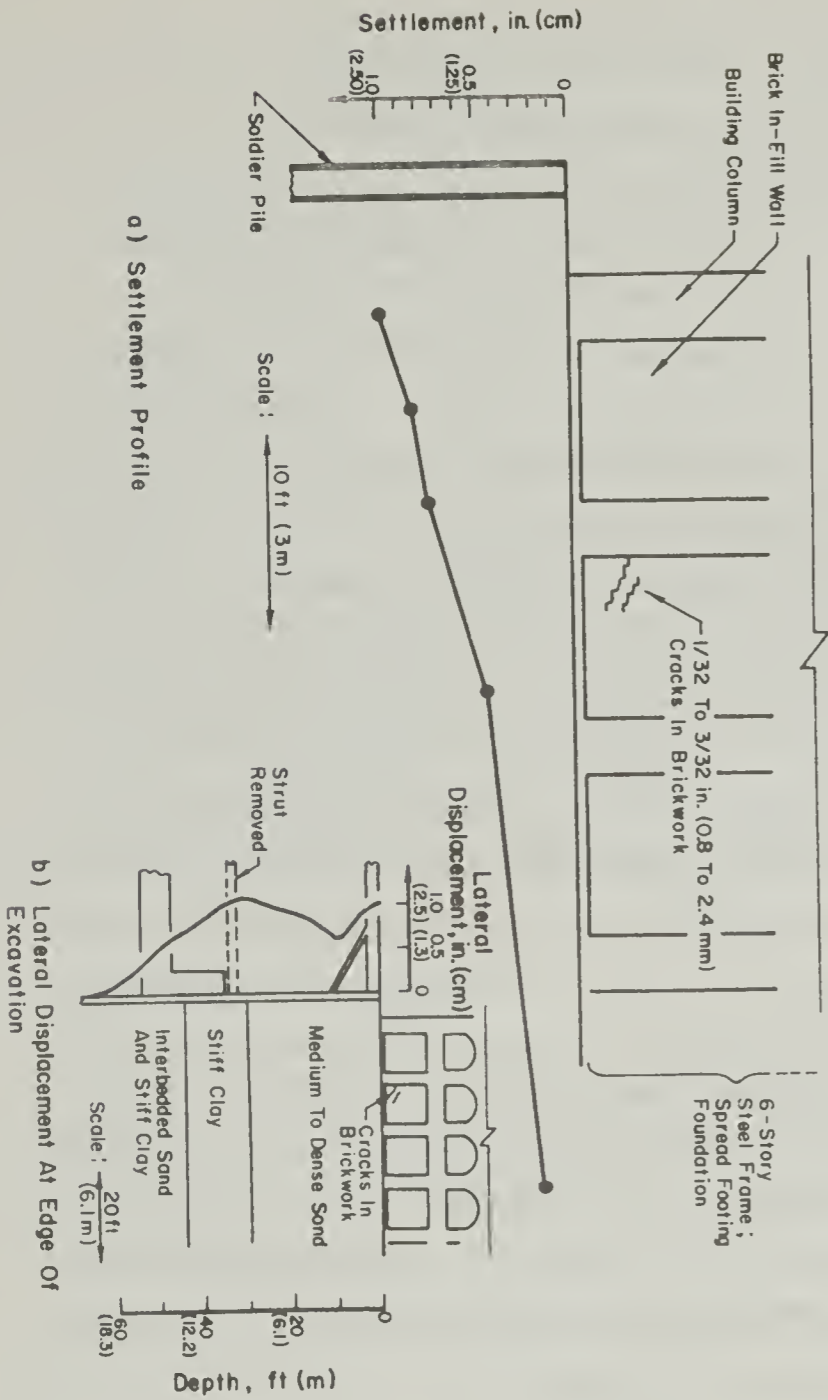
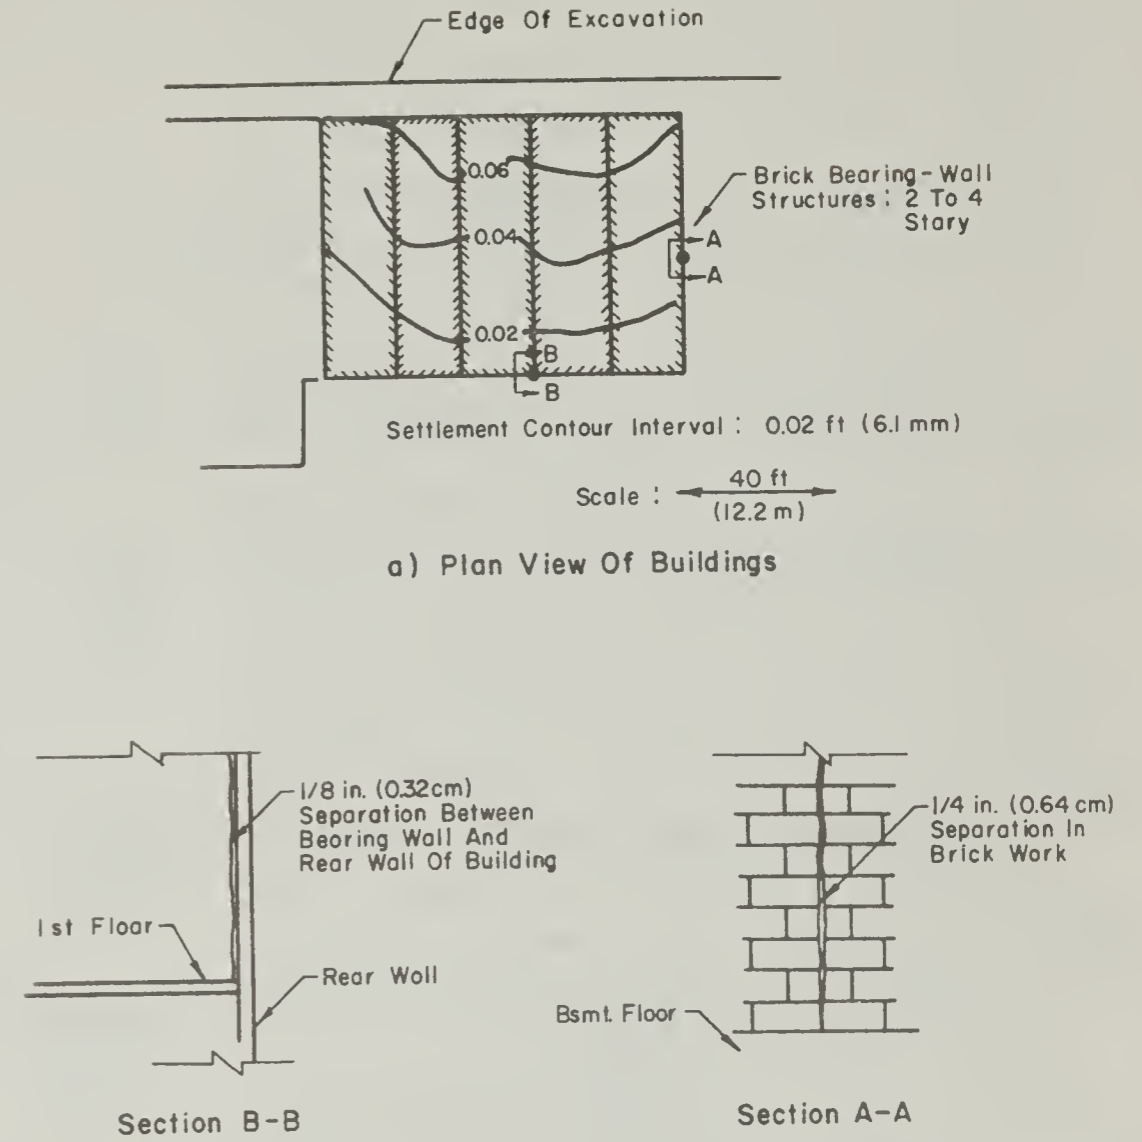
Fig. 3.10 Architectural Damage to a Row of Brick-Bearing Wall Structures

Figure 3.10 shows a plan view of five brick-bearing wall structures with respect to an 80-ft (24.4-m) deep excavation that was located 12 ft (3.7 m) from the building line. The structures range in size from 2 to 4 stories and contain one basement level each. The soil profile is similar to the profile

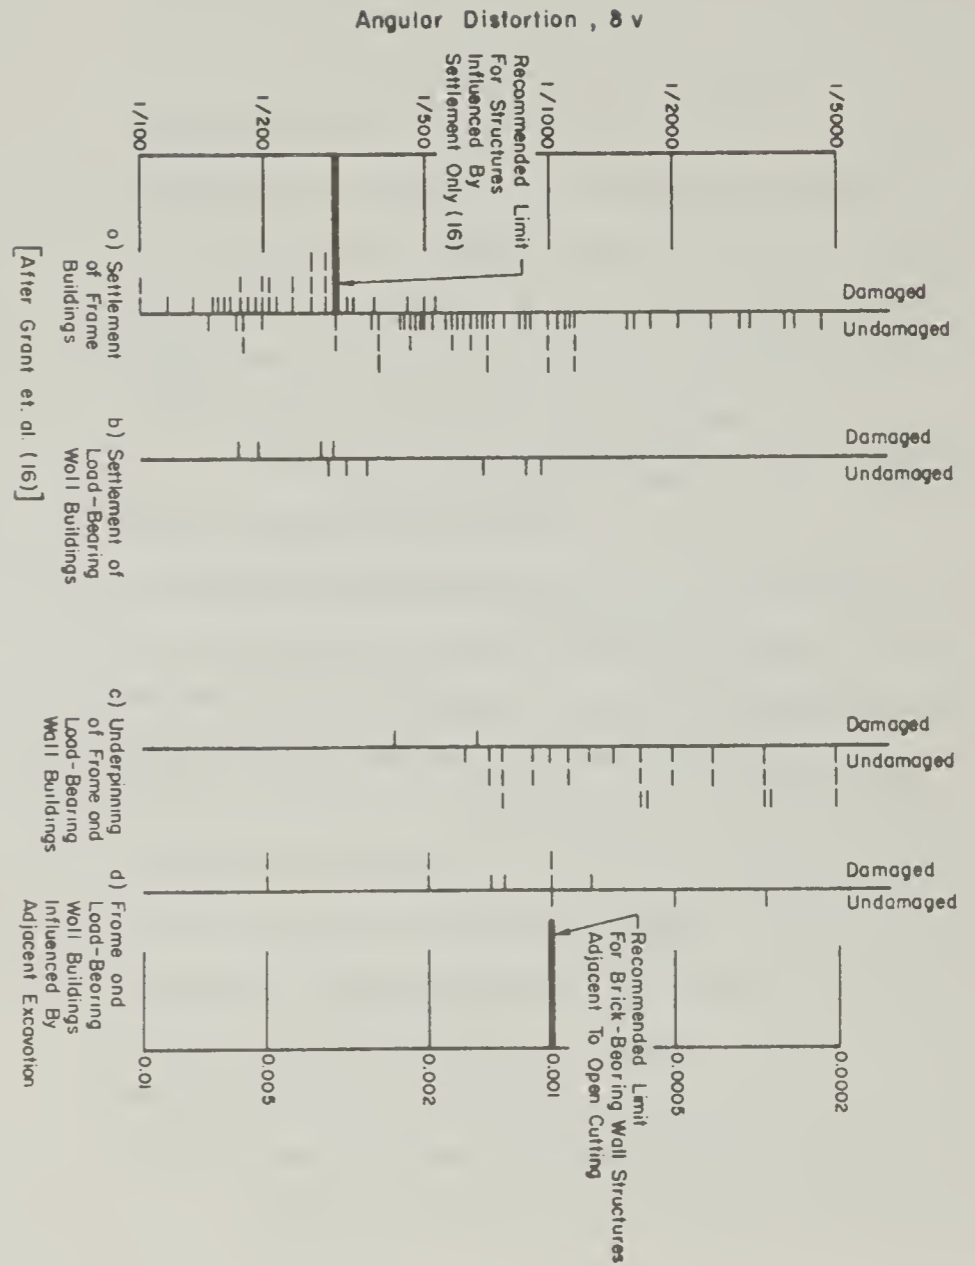
Fig. 3.11 Comparison of Field Evidence Related to Architectural Damage

Figure 3.11 compares the evidence concerning architectural damage and angular distortion as it was developed for 1) the settlement of structures under their own weight, 2) settlement caused solely by underpinning, and 3) movements associated with adjacent excavation. The summary of evidence for structures that settled under their own weight represents the combined data of Skempton and MacDonald, and Grant, et al. The limiting value of angular distortion recommended for brick-bearing wall structures adjacent to opencutting is

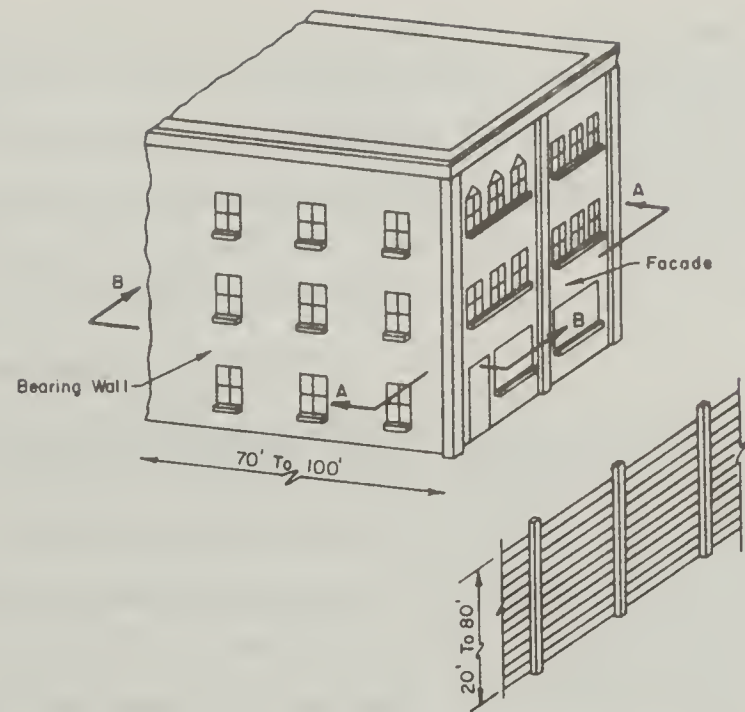
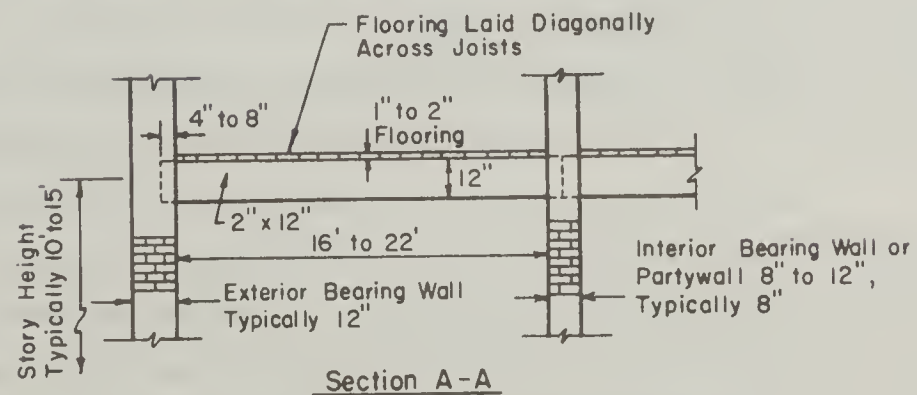
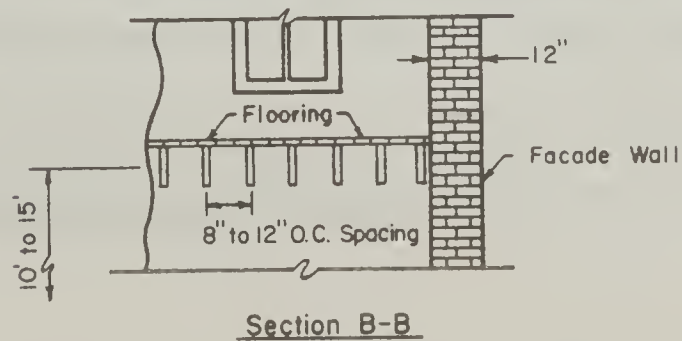
Fig. 4.1 Typical Brick-Bearing Wall Structure

Brick-bearing wall structures are used for both commercial and domestic purposes. The commercial units are generally from two to five stories high, while the domestic units, such as town houses, are two or three stories high. A typical brick-bearing wall structure is illustrated in Fig. 4.1, adjacent to

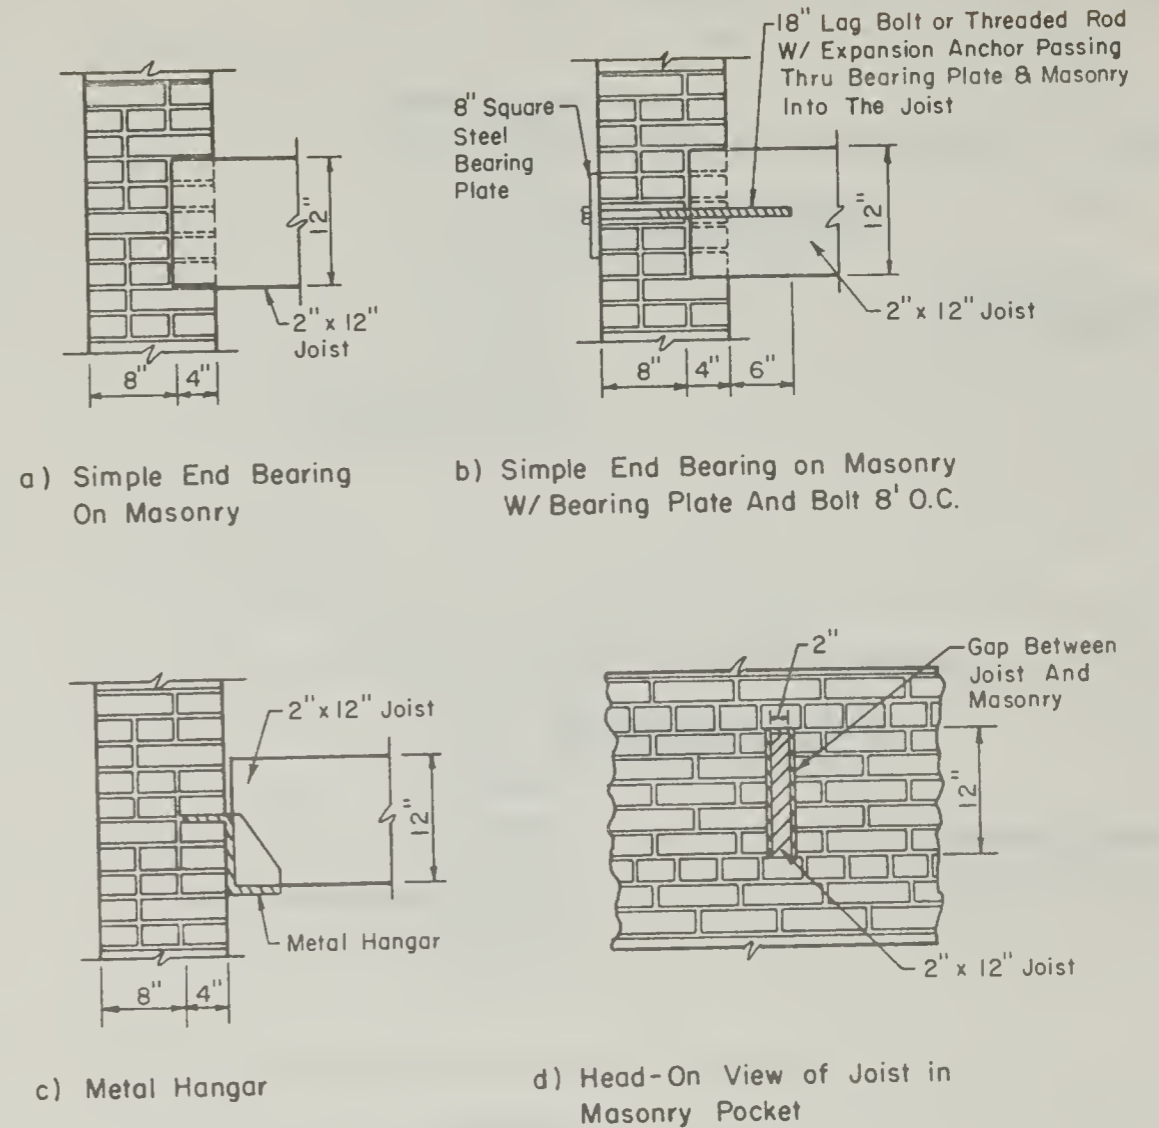
Fig. 4.2 Typical Masonry - Joist Connections

All of the connections described above have one common characteristic. They provide very little, if any, fixity at the ends of the joists. As indicated by the head-on view in Fig. 4.2, there is a space between the joist and

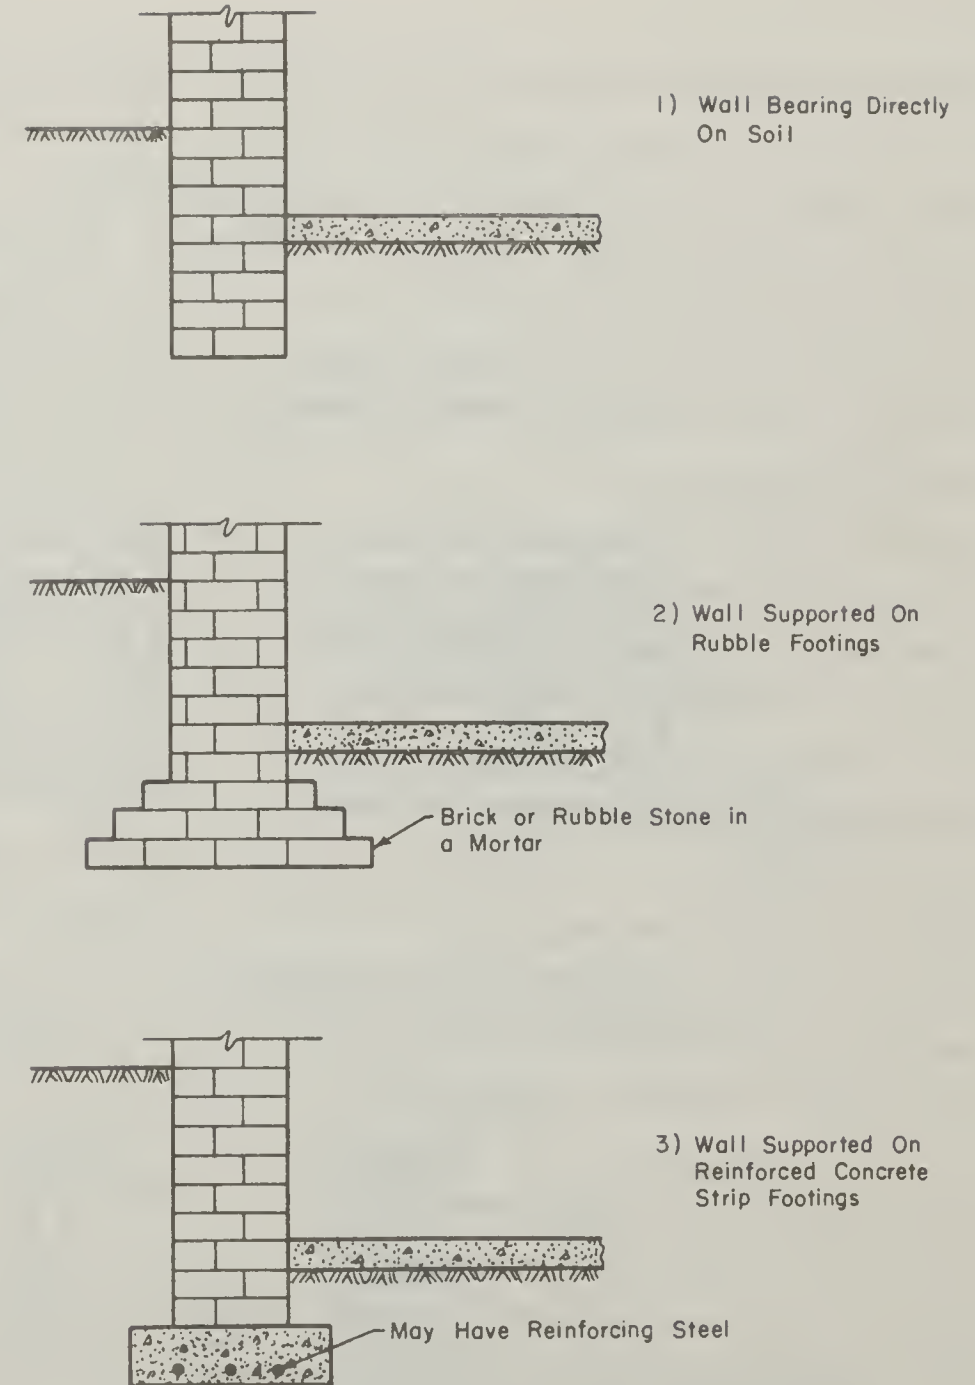
Fig. 4.3 Typical Foundations for Brick-Bearing Wall Structures

In the more modern structures, the building walls are supported on continuous strip footings. These footings are often reinforced along their bottom portion and, thus, represent a condition more favorable for underpinning.

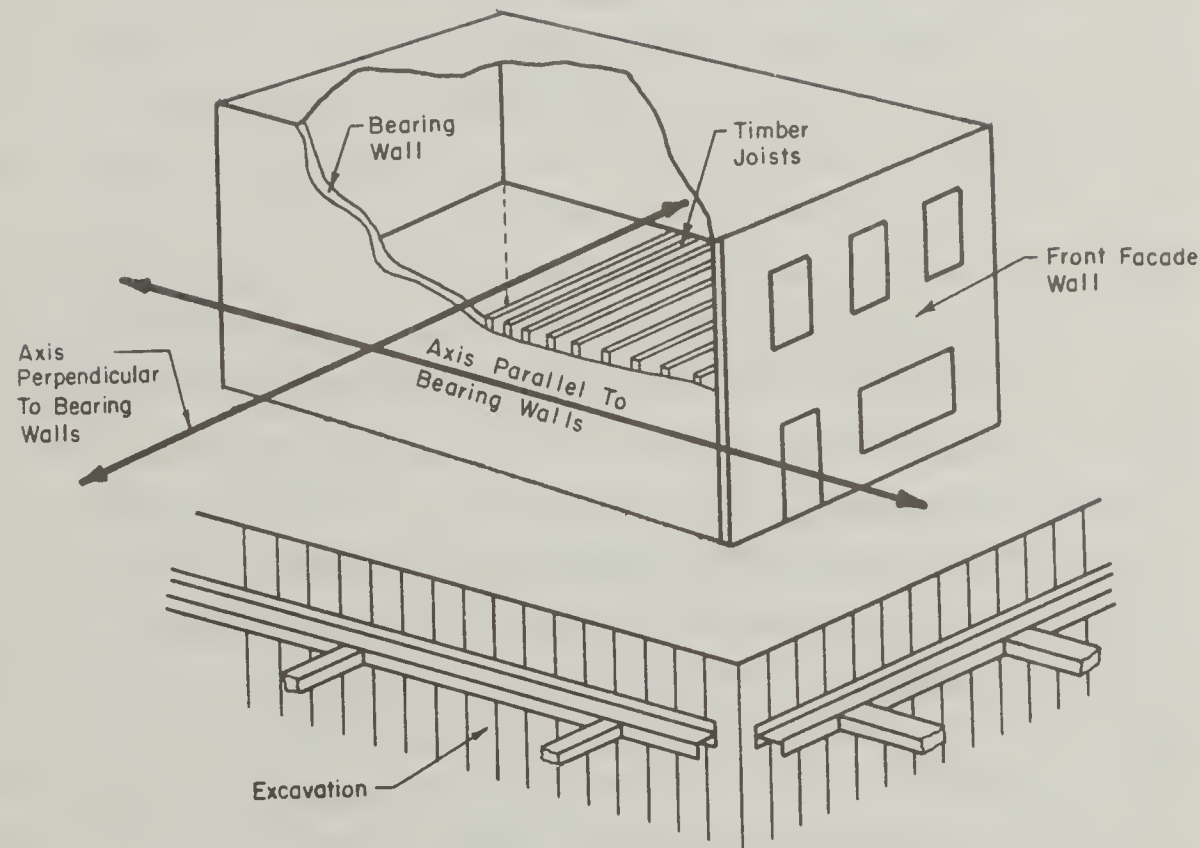
Fig. 4.4 Axes of Structural Response for Brick-Bearing Wall Structures

Although for most structures the bearing walls are oriented parallel to the long dimension of the building, this need not always be the case. As was mentioned previously, the bearing walls for some structures, especially those used for domestic purposes, are aligned parallel to the short dimension of the buildings. There is no general way to identify this type of construction other than by direct inspection. Consequently, brick-bearing wall structures near areas of anticipated excavation should be examined to determine the orientation of the bearing walls prior to construction.

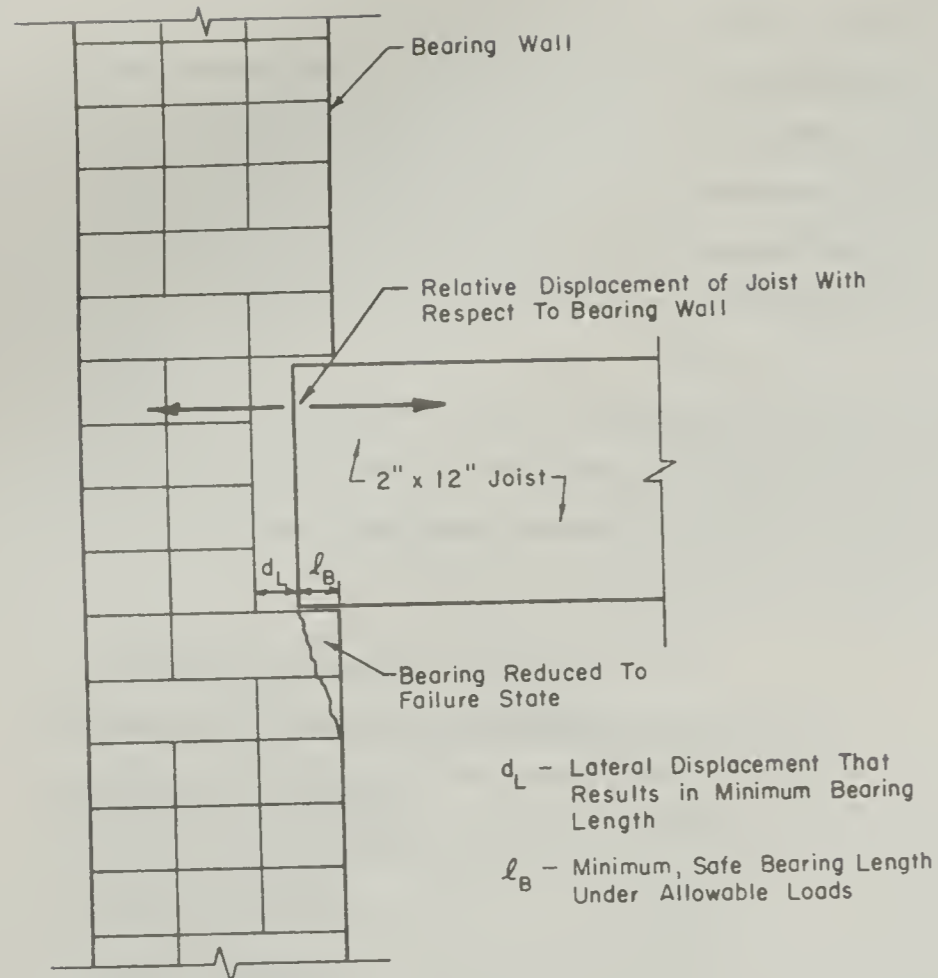
Fig. 4.5 Critical Bearing Condition for the Masonry - Joist Connection

The most critical feature with respect to building stability is the masonry-joist connection. Ground movements perpendicular to the bearing walls cause relative displacement of the walls which, in turn, diminishes the bearing area available for the joist. Figure 4.5 shows a condition of incipient failure. The wall has moved relative to the joist such that the bearing area has been reduced to the point where a bearing failure is imminent. The maximum tolerable movement is simply the lateral displacement, d_L , corresponding to a minimum bearing length, l_B , that is safe under an allowable load criterion. The minimum bearing length is a function of the compressive strength of the masonry. This strength can vary over a wide range of values depending on the age and material properties of the brick and mortar. Consequently, the critical aspect of this analysis is the choice of a strength parameter that represents a conservative, yet reasonable estimate of typical field conditions.

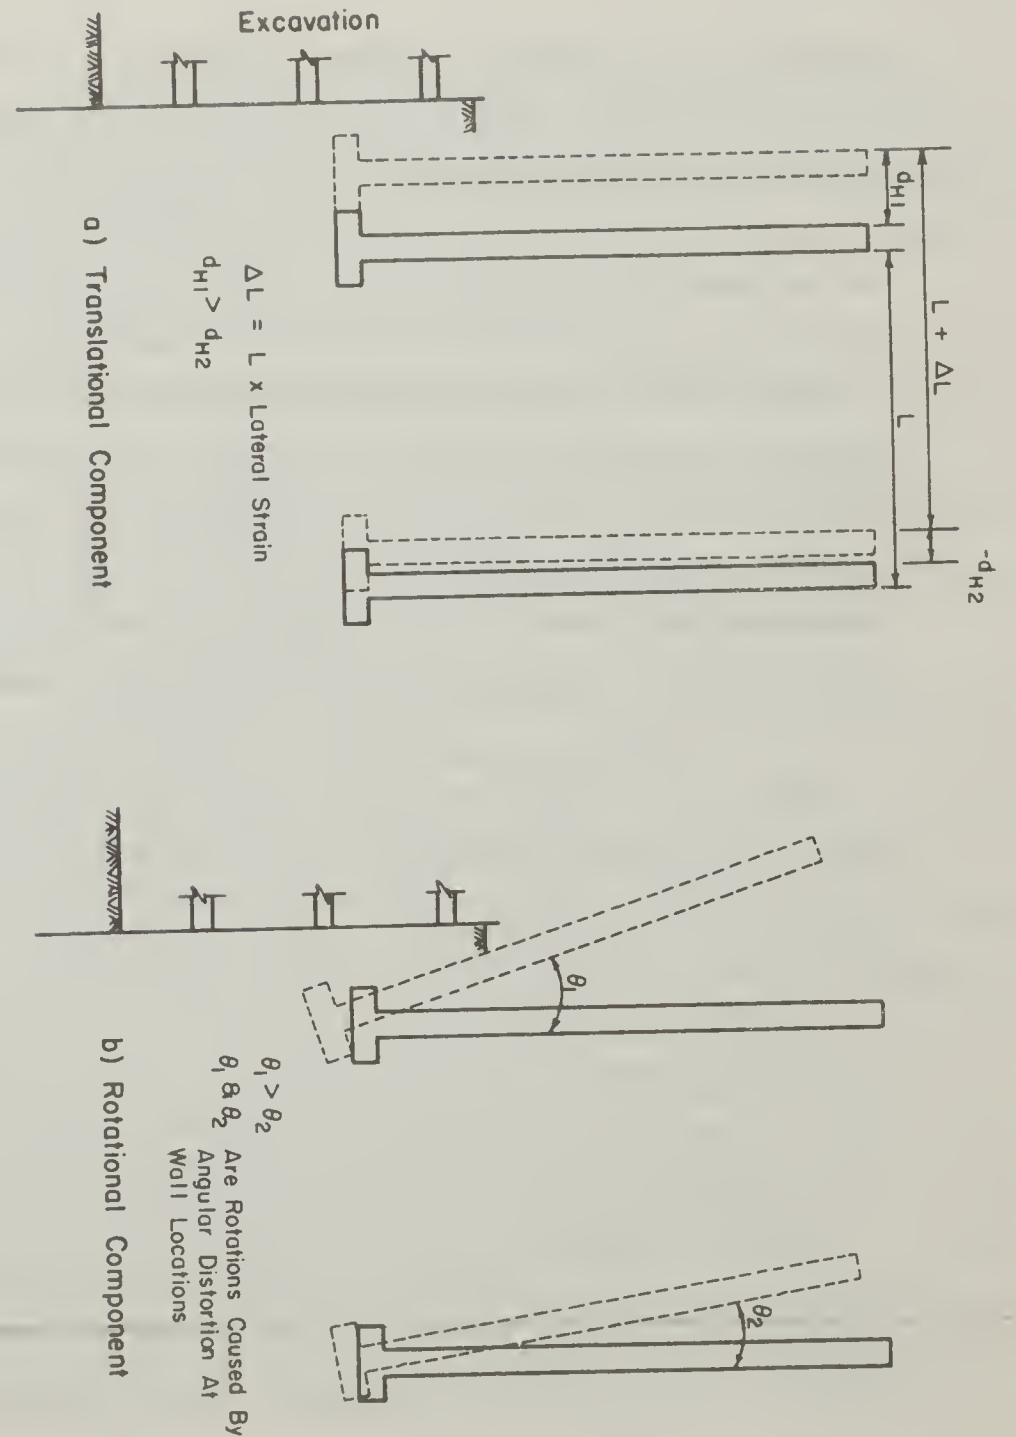
Fig. 4.6
Translational and Rotational Components of the
Differential Lateral Movement Between Bearing Walls

differential rotation of the bearing walls also increases the wall separation. It is difficult to evaluate how angular ground distortion is translated into differential rotation of the bearing walls. The loss of joist bearing contributed by wall rotation will be a function of the stiffness of the bearing wall with respect to the restraining forces at the masonry-joist connections. More observational and analytical work are needed to understand this aspect of the building behavior. For the conservative assumption of rigid wall rotation, the maximum relative displacement of one wall with respect to the other will be proportional to the wall height. For a 5-story structure, a relative rotation of 4×10^{-3} radians could be sufficient to reduce the joist bearing to an unsafe condition in the upper story of the building.

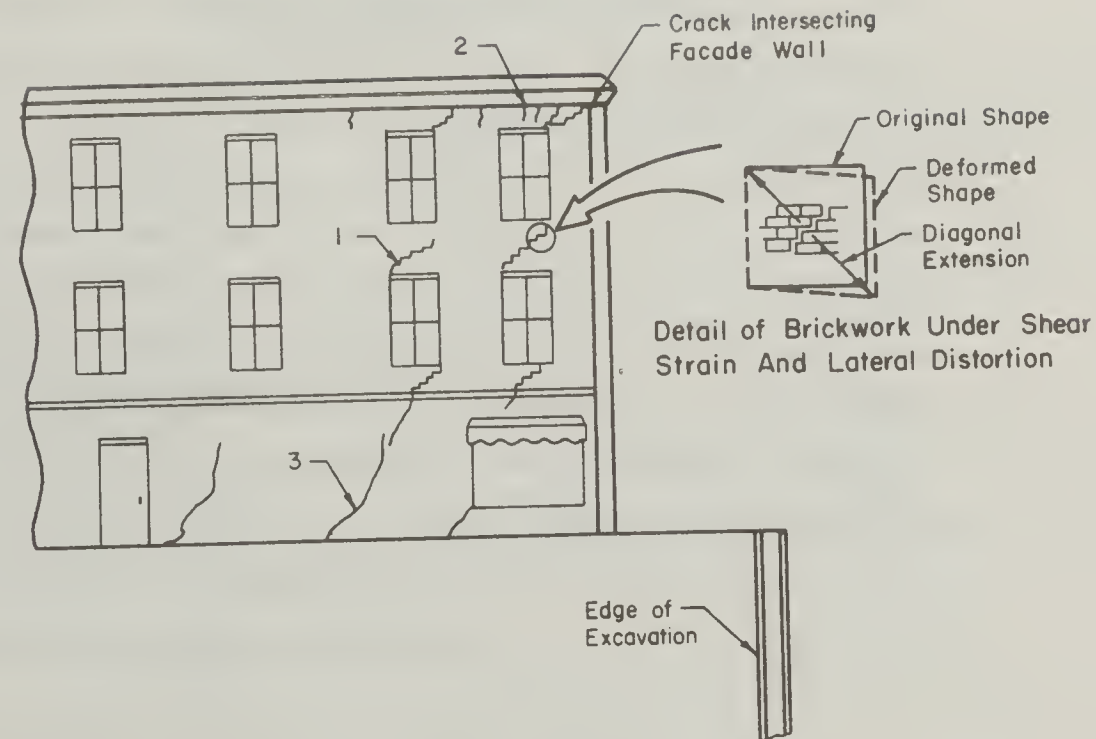
Fig. 4.7 Typical Fracture Patterns Observed in Brick-Bearing Wall Structures Adjacent to Excavation

3. Vertical and near vertical cracks occurred near the base of the building. These cracks generally extended from the ground surface to heights of 5 to 10 ft (1.5 to 3.0 m).

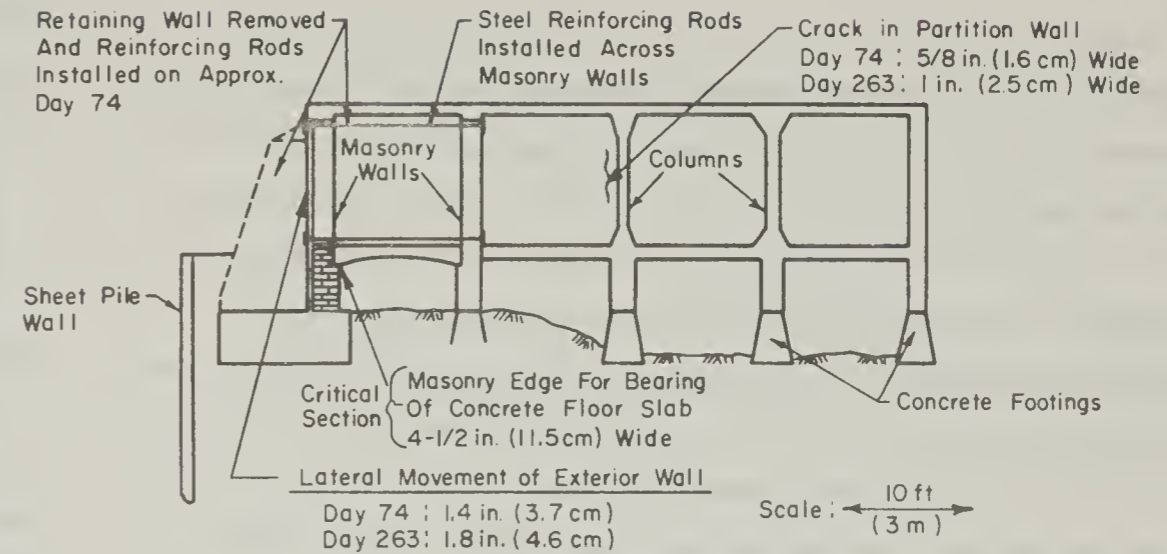
a) Detail of Rail Station

As indicated in the figure, the most critical section of the building with respect to soil movement was located in the structural bay closest to the cut. Stability in this area was related to the masonry bearing provided for the floor slab. Hence, the stability was controlled by the differential lateral movement of adjacent bearing walls. Building plans indicated that the bearing

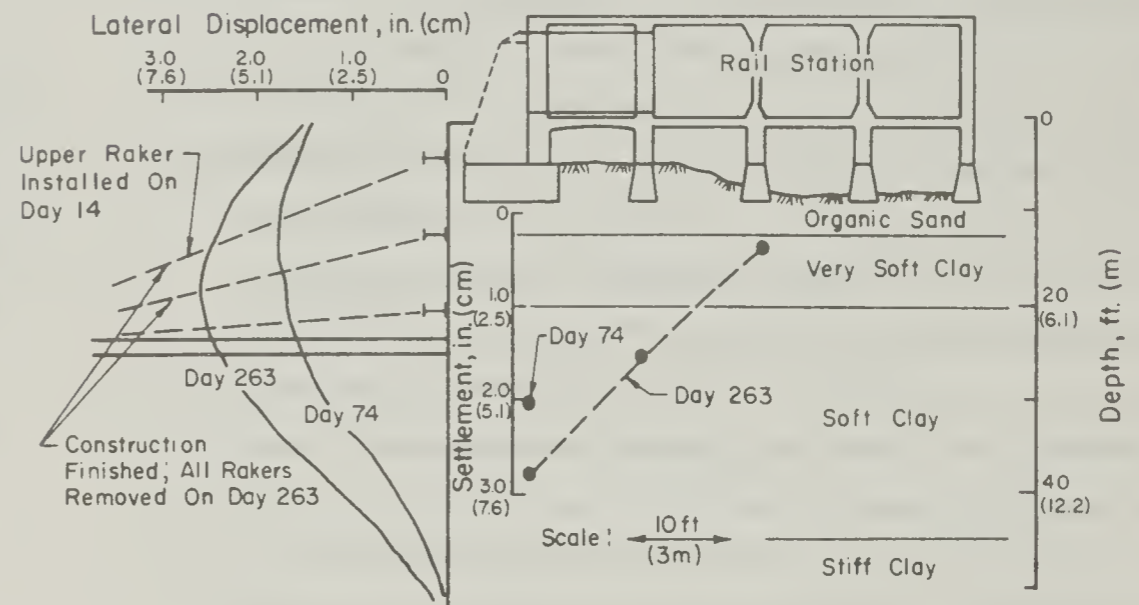
b) Vertical and Lateral Displacement Profile

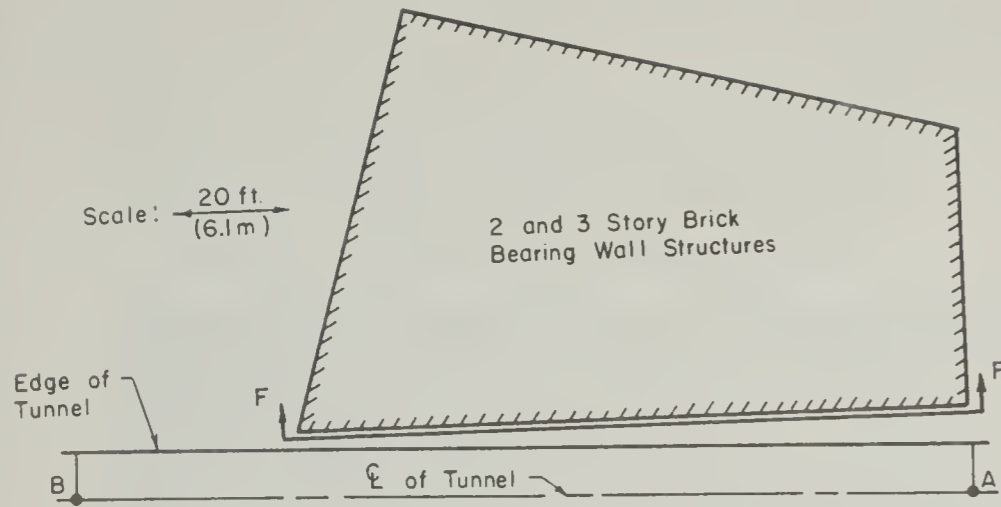
a) Plan View of Tunnel and Buildings Along Path of Tunnel

Figure 4.9 shows the maximum angular distortions plotted with respect to their location along the building line. By comparing the observed damage at the store fronts with the locations and magnitudes of the maximum angular distortions, it is possible to evaluate how building damage is related to various intensities of deformation. Figure 4.9 shows that, for the structures near point A, a maximum angular distortion of 2.8×10^{-3} (1/357) corresponds to minor cracks and separations at the facade of the building. During tunneling, there were no complaints from the occupants of the structures in this vicinity. The

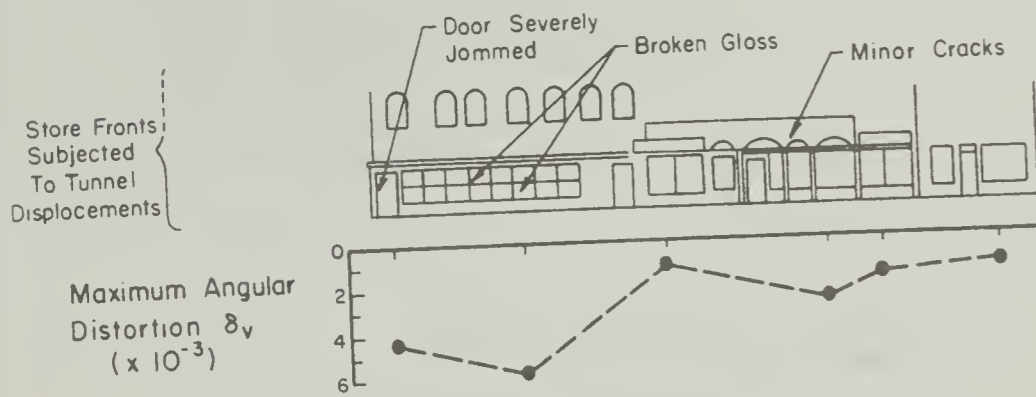
b) Profile of Store Fronts (Section F-F) With Maximum Angular Distortion and Location of Damage
